RAILWAY INVESTIGATION REPORT
R99H0009

COLLISION AT CROSSING

VIA RAIL CANADA INC.

MILE 290.50, RUEL SUBDIVISION

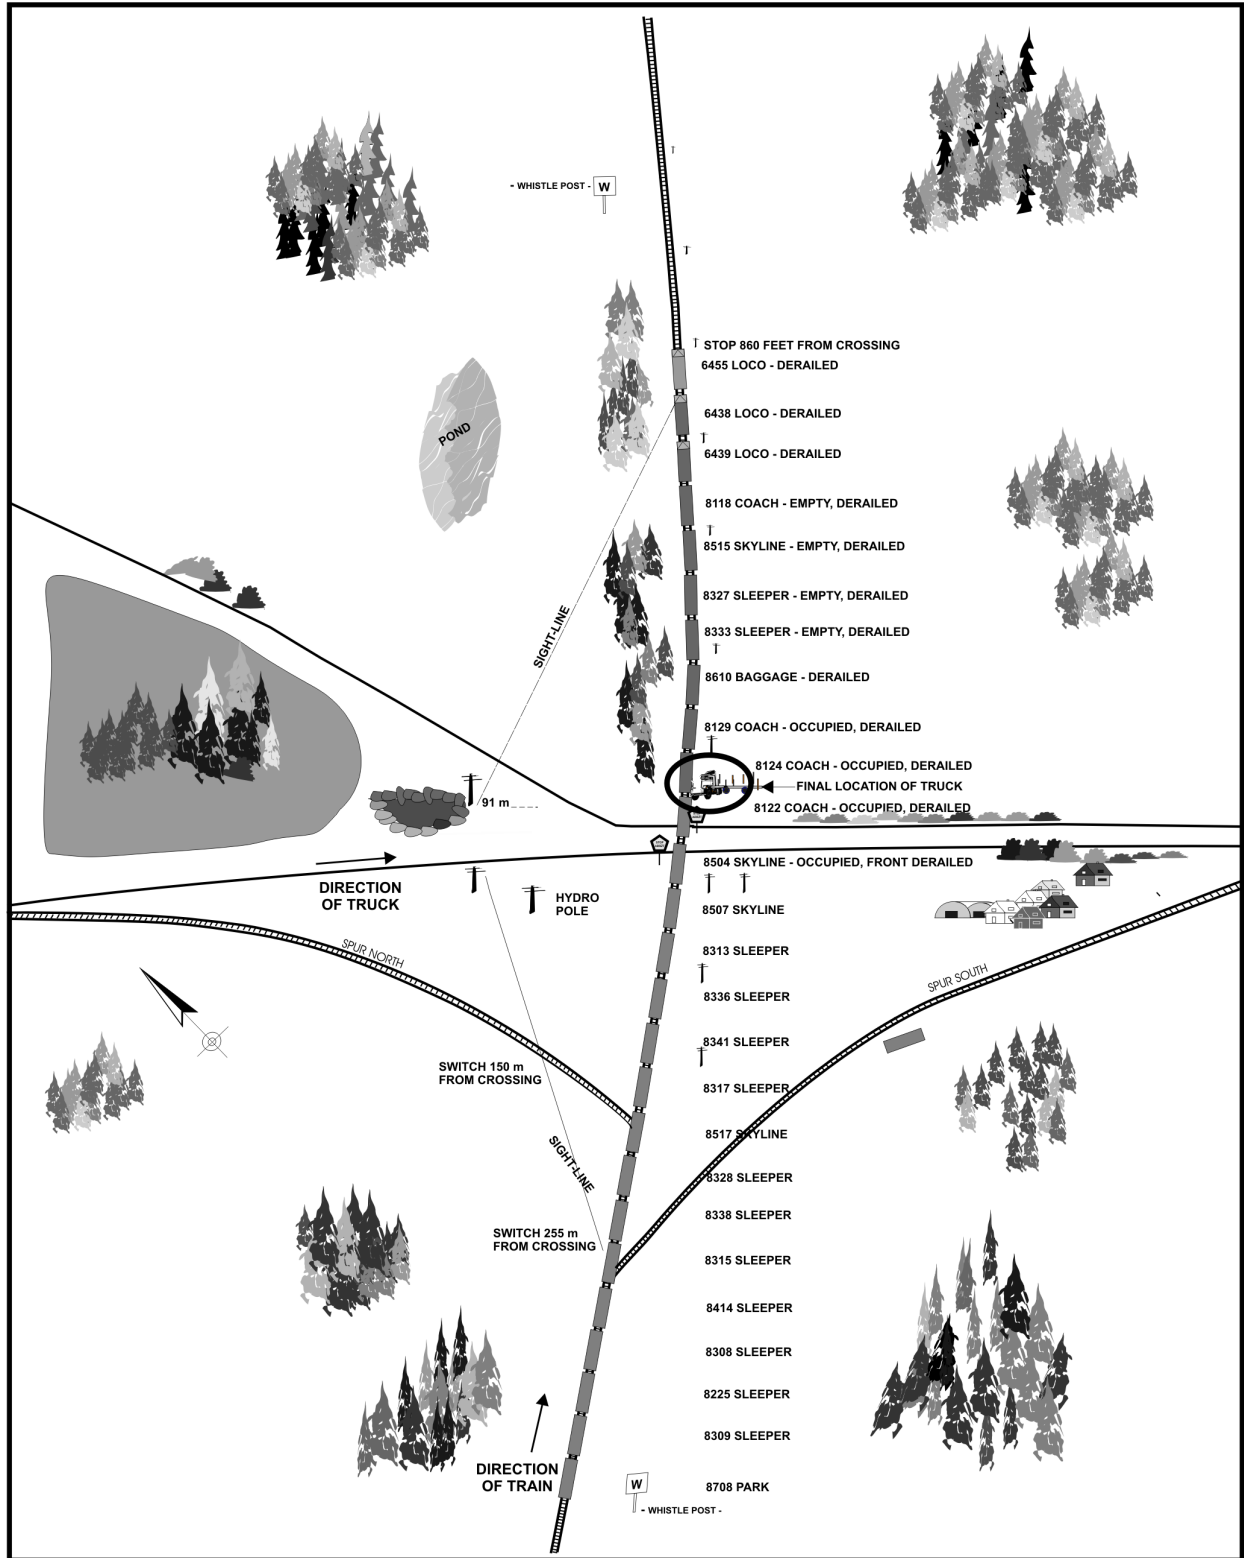
Figure 5—Diagram of the occurrence area

The CN Ruel Subdivision consists of a single main track. It links Capreol to Hornepayne, a distance of 296 miles. The maximum allowable track speed was 70 mph for passenger trains and 60 mph for freight trains. In the accident area, the maximum allowable speed was 60 mph for passenger trains and 55 mph for freight trains. At Mile 290.5, there is a 0.5 per cent descending grade in an eastward direction and there is a slight curve (one degree) beginning approximately 98 m west of the Becker crossing. There is a large pond immediately east of the Becker crossing just north of the main track (see Figure 5).
